**Dam Safety Assessment of CCW
Impoundments**

**LG&E Mill Creek Station
Report**

October 2009

Dam Safety Assessment Report of CCW Impoundments LG&E Mill Creek Station

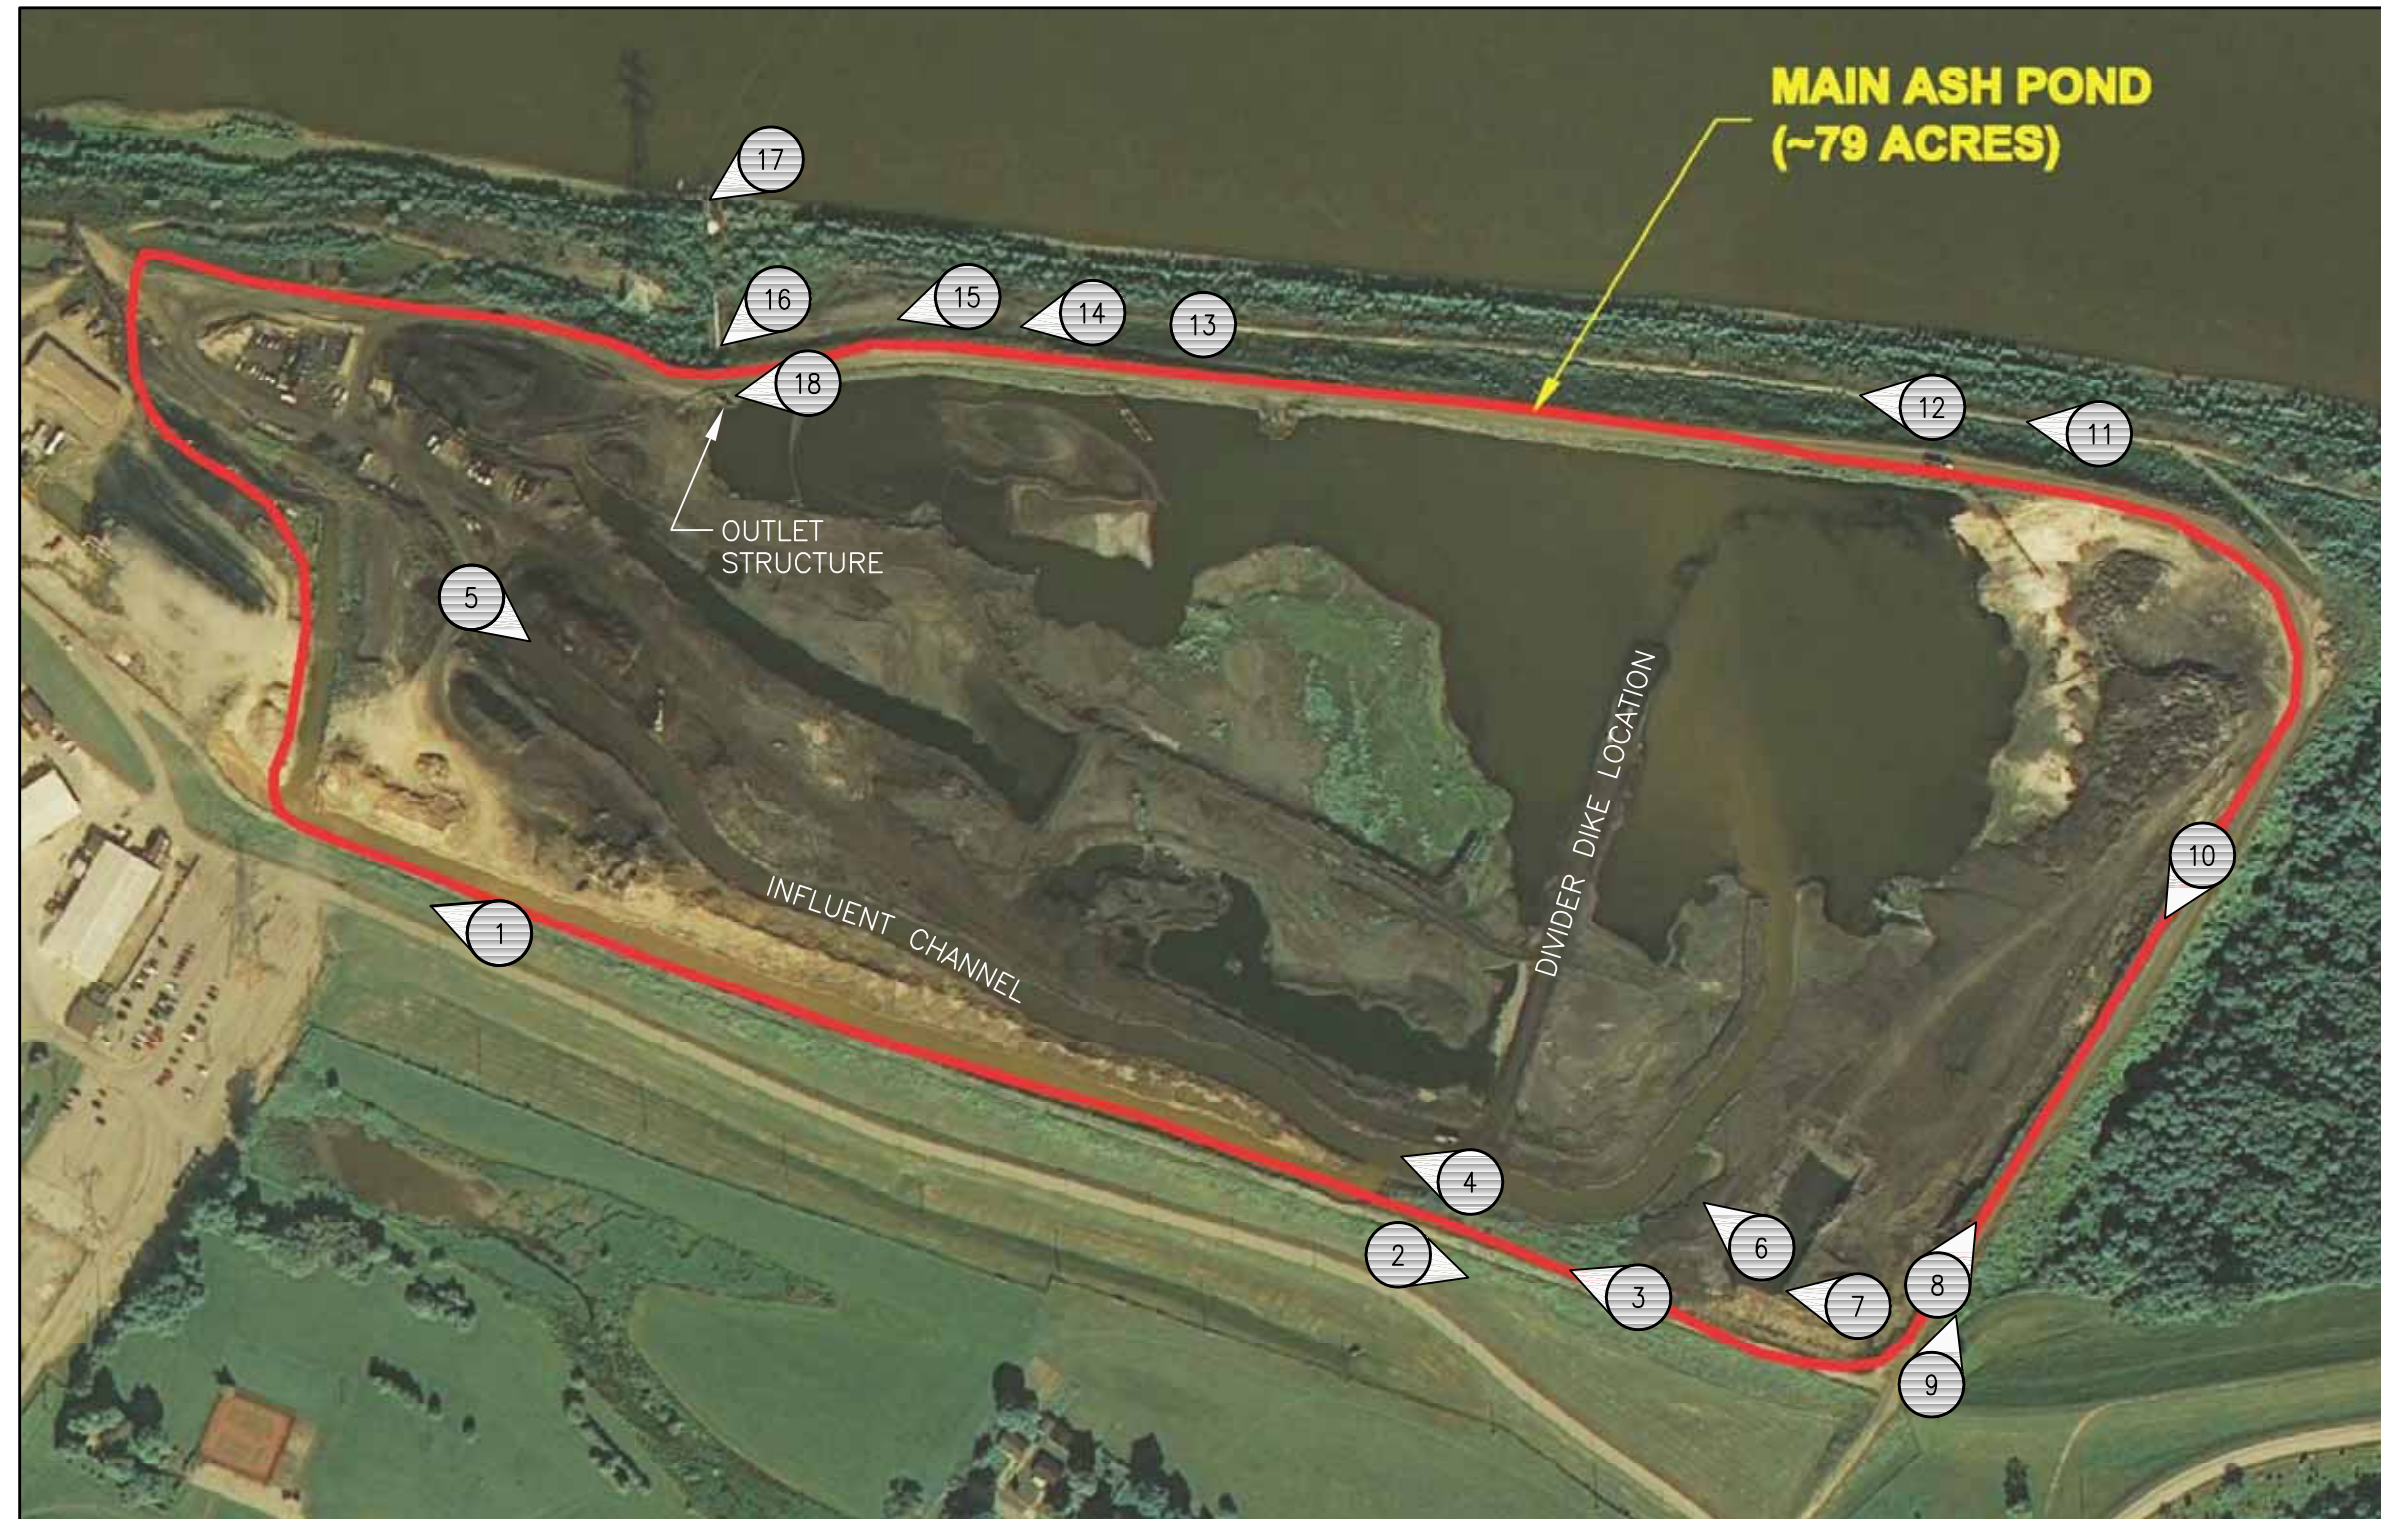
FIGURE 3

Photos of relevant features and conditions observed during the inspection were taken by O'Brien & Gere and are provided in Appendix B. An aerial photograph of the Ash Pond is presented as Figure 3, which provides photograph locations and directions. This aerial photograph is believed to have been taken in 2006.
